27 August 1999

U.S. EPA Contract No. 68-W7-0026
Work Assignment No. 003-ROBF-05AN
Document Control No. RFW003-2C-ADGK
Subject: Oversight of Remedial Activities
Albion-Sheridan Landfill Site

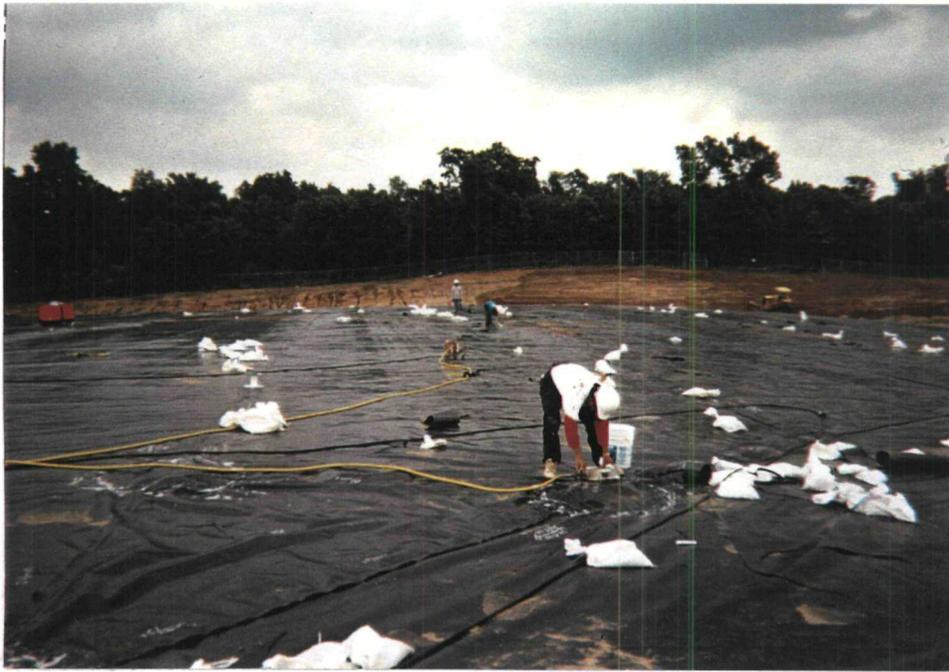
PHOTO #1: VACUUM TESTING OF AN EXTRUSION WELD.
19 JULY 1999

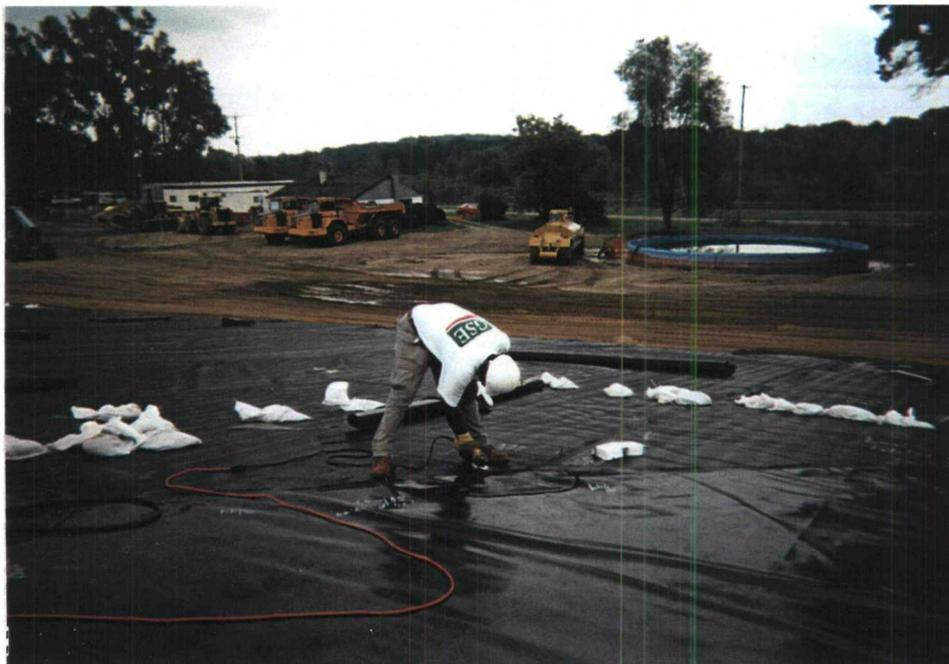
PHOTO #2: ROUGHING AND GRINDING OF AN AREA BEFORE EXTRUSION WELDING.
19 JULY 1999

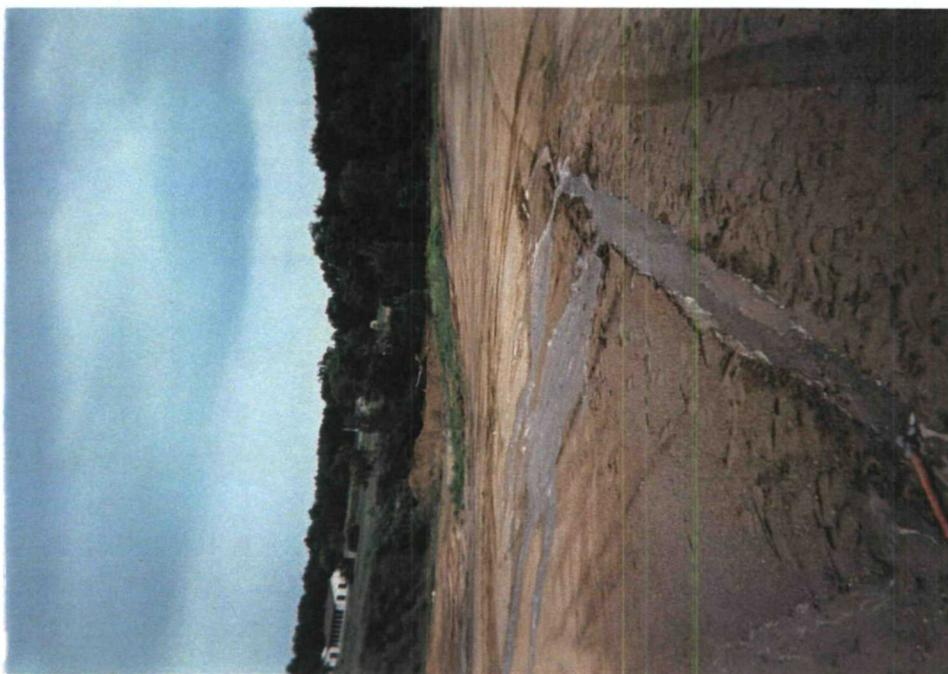
PHOTO #3: WATER FROM THE SEEP AREA BEING PUMPED ONTO THE LANDFILL.
19 JULY 1999

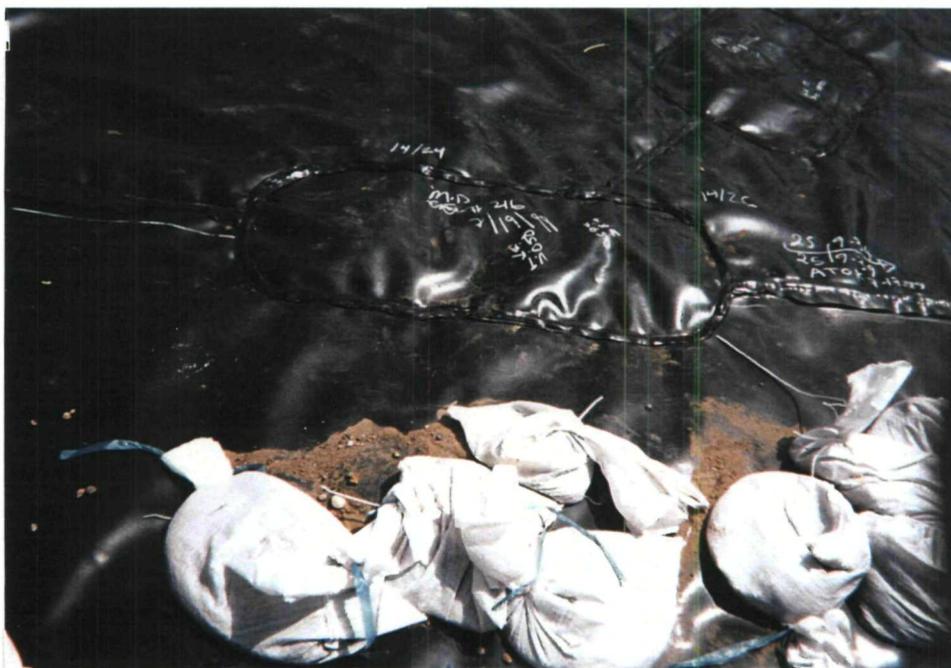
PHOTO #4: COMPLETED EXTRUSION WELD.
22 JULY 1999

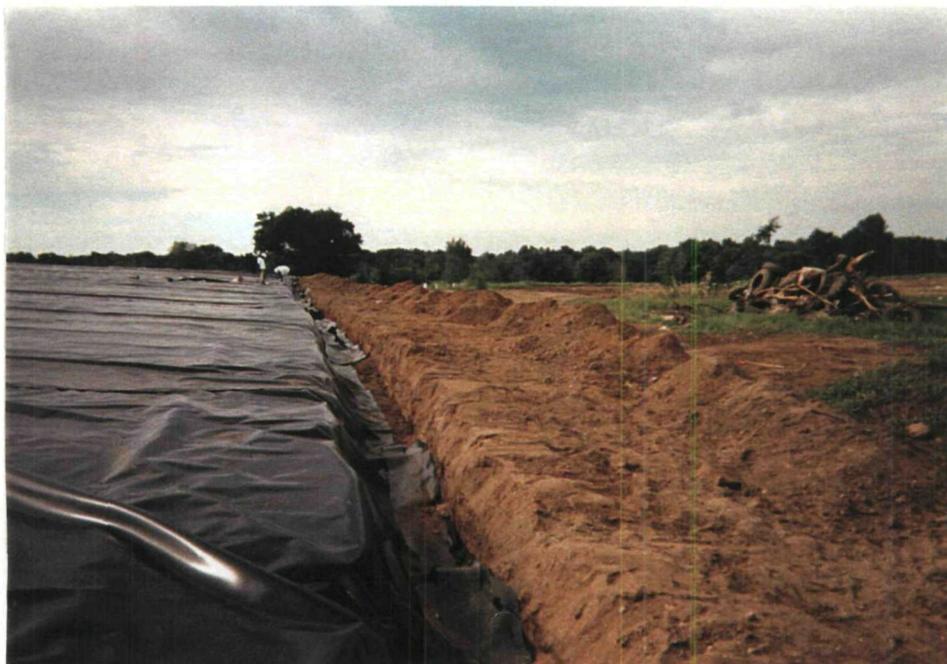
PHOTO #8: ANCHOR TRENCH ON THE WEST SIDE OF THE LANDFILL.
29 JULY 1999

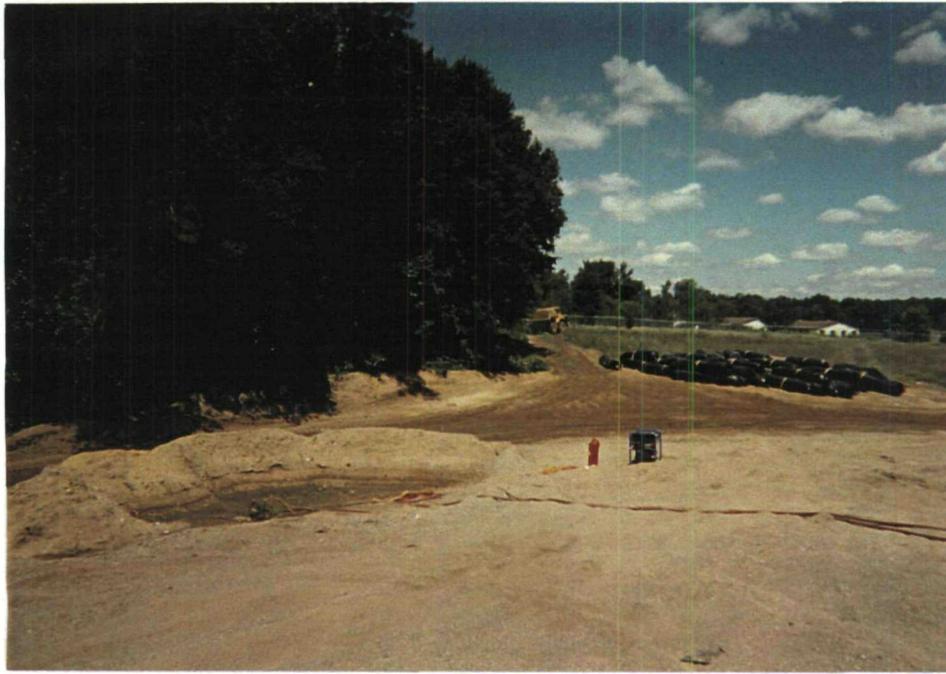
PHOTO #9: VIEW OF THE SEEP AREA.
3 AUGUST 1999

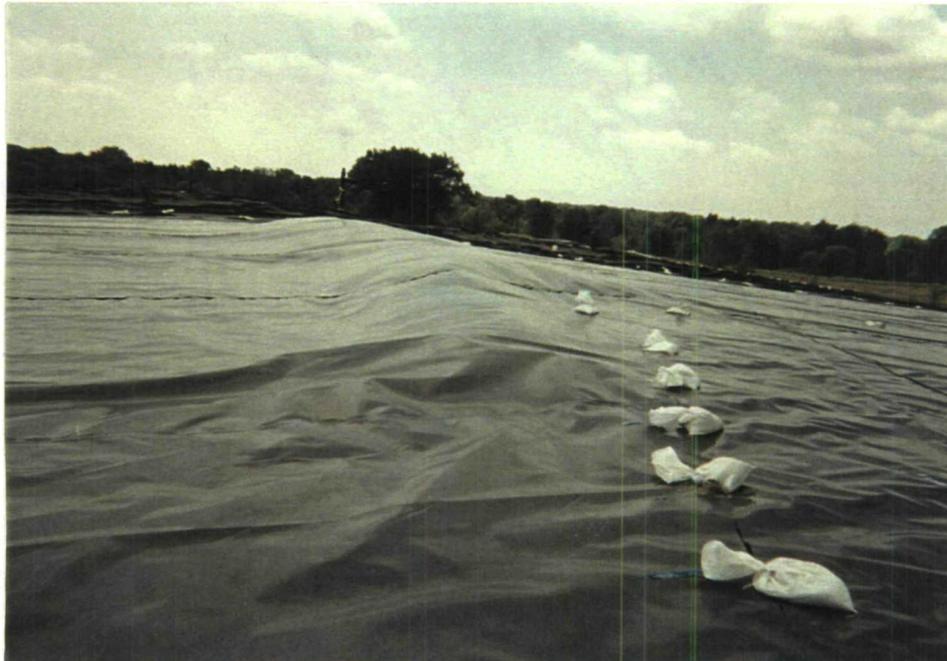
PHOTO #12: FORMATION OF A METHANE POCKET UNDER THE GEOMEMBRANE NEAR PASSIVE
GAS LINE #4. 6 AUGUST 1999

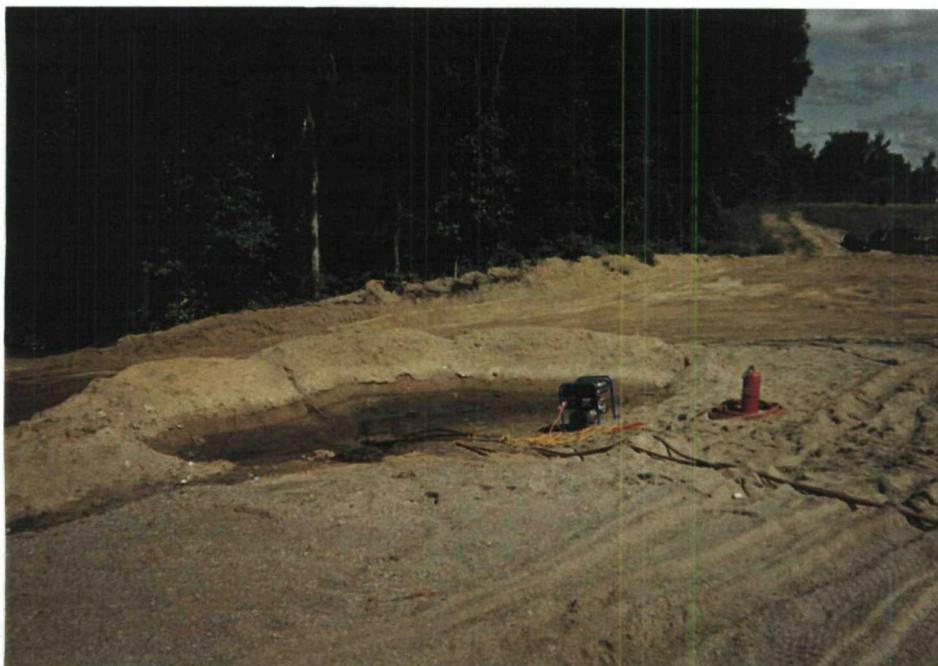
PHOTO #14: WATER FROM THE SEEP AREA BEING PUMPED TO THE TOP OF THE LANDFILL.
6 AUGUST 1999

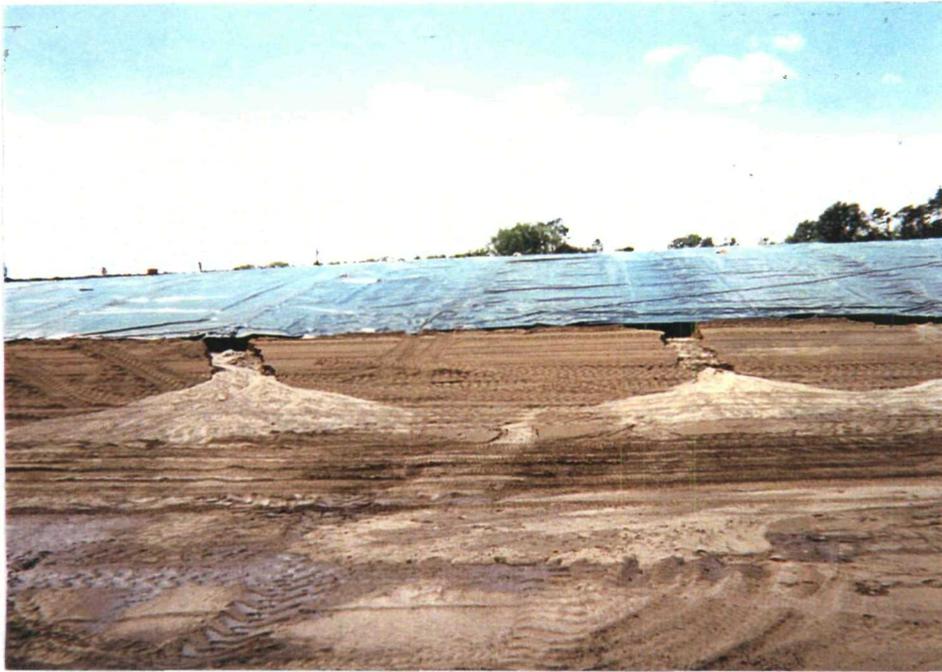
PHOTO #15: EROSION OF GAS COLLECTION LAYER BELOW THE GEOMEMBRANE DUE TO HEAVY RAINFALL. 9 AUGUST 1999

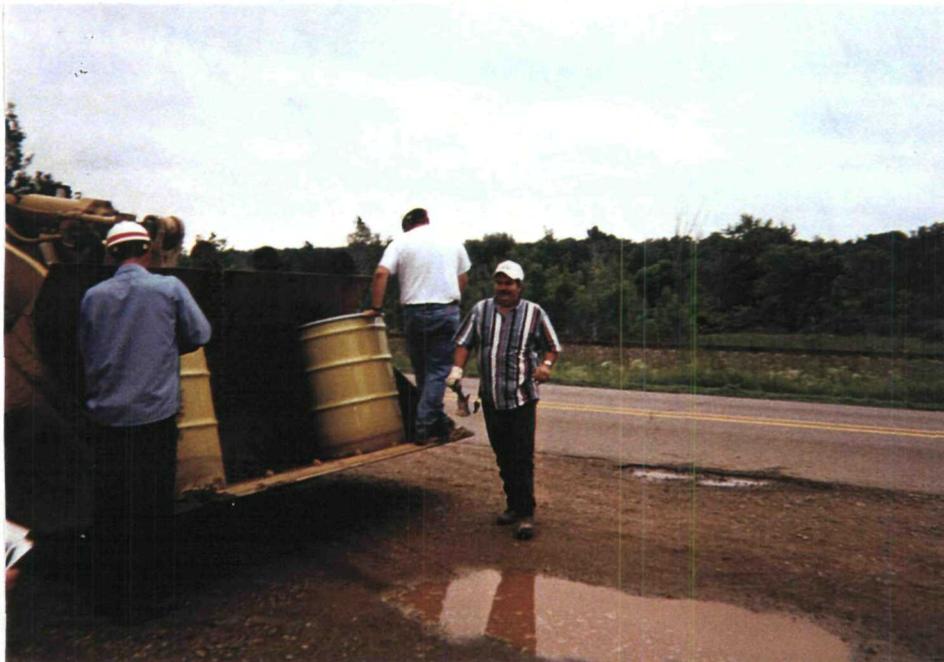
PHOTO #16: LOADING OF DRUMS FOR OFF-SITE DISPOSAL. 10 AUGUST 1999

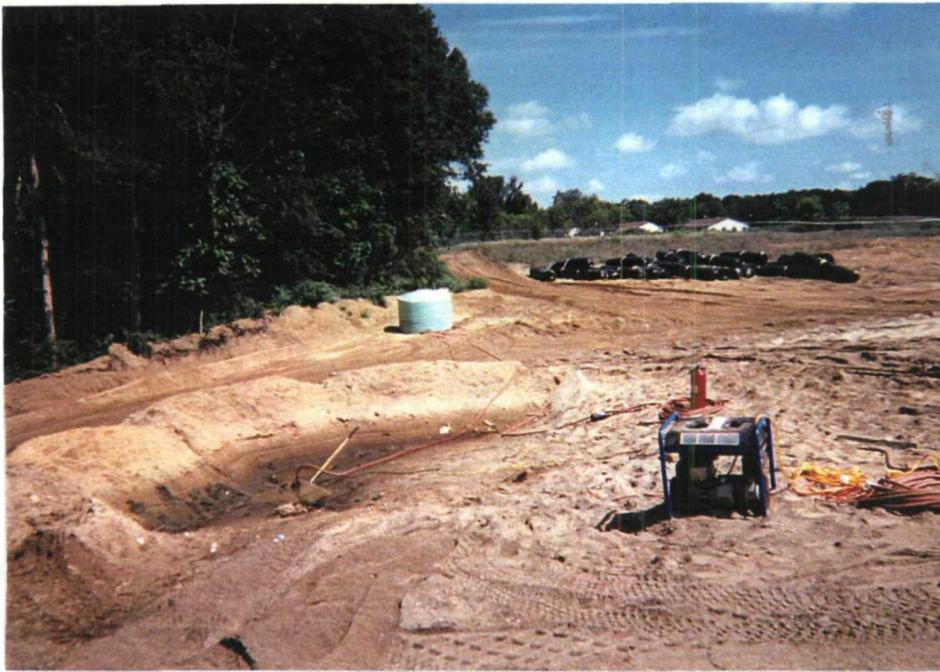
PHOTO #17: PUMPING OF WATER FROM THE SEEP AREA INTO A HOLDING TANK.
11 AUGUST 1999

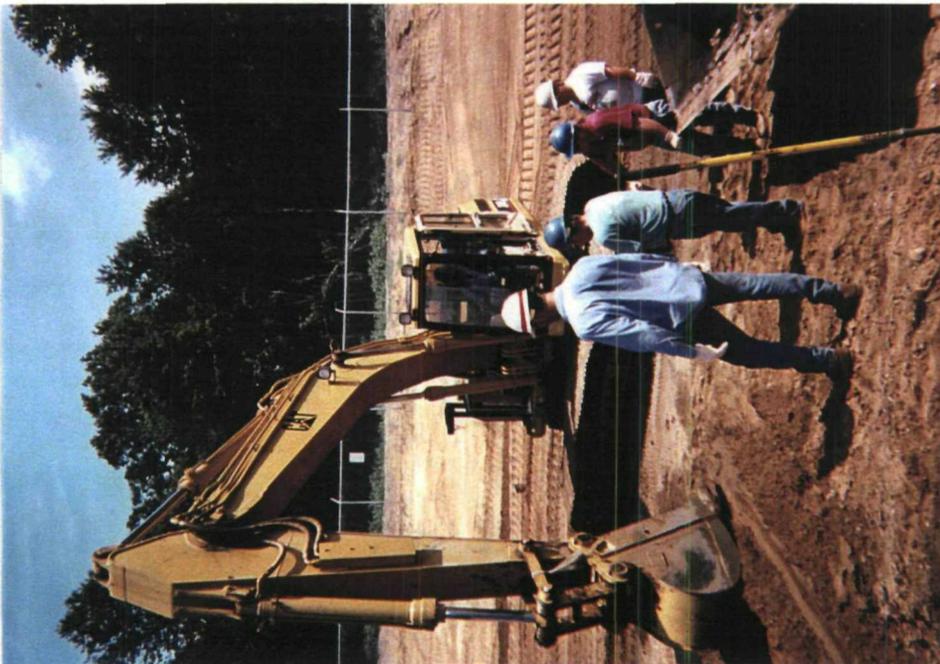
PHOTO #18: REMOVAL OF SURFICIAL WASTE ON THE EAST SIDE OF THE LANDFILL.
11 AUGUST 1999 (NOTE: THIS WASTE WAS EXPOSED AFTER HEAVY RAINFALL.)

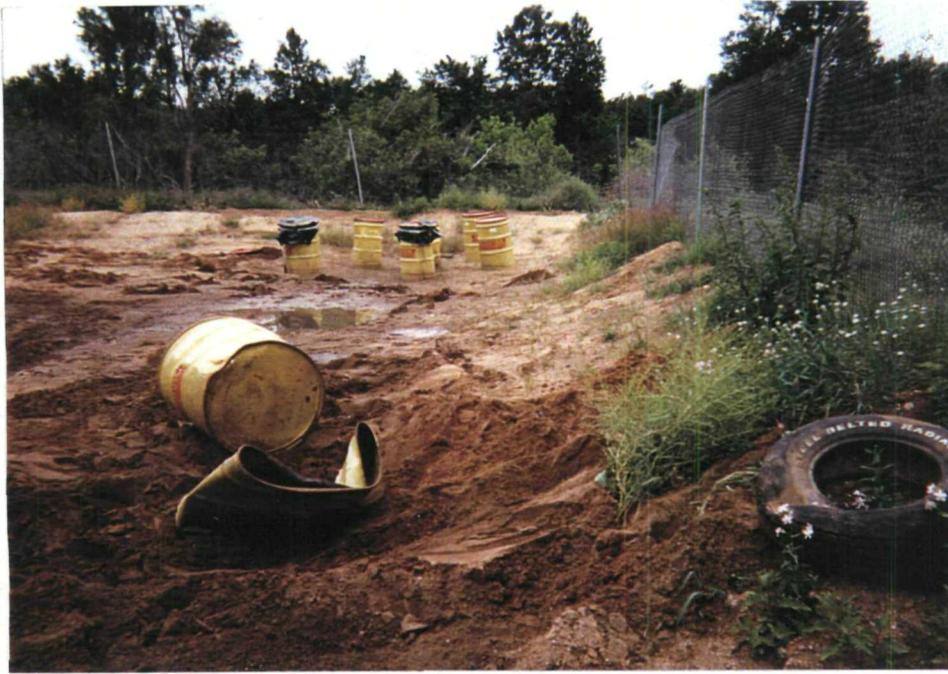
PHOTO #19: CRUSHED DRUMS AND OVERPACKS IN THE DRUM STORAGE AREA.
12 AUGUST 1999

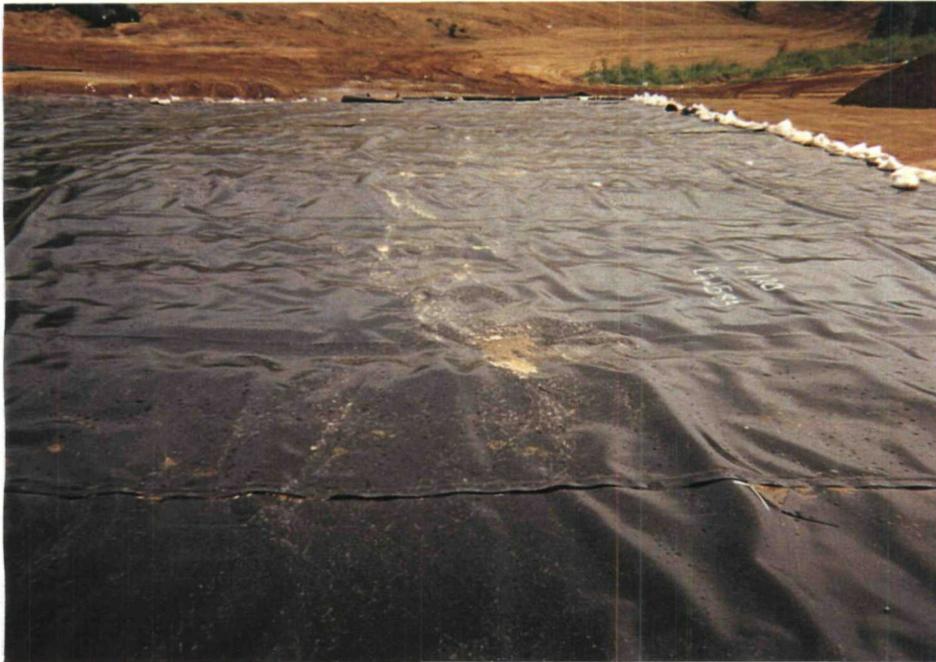
12:00 Mike (GSE) on-site
 - asked him why geomembrane was laid in W-E when liner should be laid parallel to greatest slope
 - Tom (W-C) wanted to get seep area covered fast and W-E orientation was the quickest

PHOTO #20: PLACEMENT OF GEOMEMBRANE ON THE NORTH SIDE OF THE LANDFILL.
13 AUGUST 1999 (NOTE: GEOMEMBRANE SEAMS ARE NOT PLACED PARALLEL
TO THE MAXIMUM SLOPE.)
